Test Report

Report No: SHRLN0036/2007

SHANGHAI KAKU ELECTRIC EQUIPMENT CORP.

Product Description	: KA-1238/AC FAN
Quantity	: 2pieces
Sample Receiving Date	: Nov. 15, 2007
Testing Period	: Nov. 15, 2007
Test Request	: IP55
Test Method	: Refer to IEC60529-2001 and client's requirement.
Test Result(s)	: For further details, please refer to the following pages.

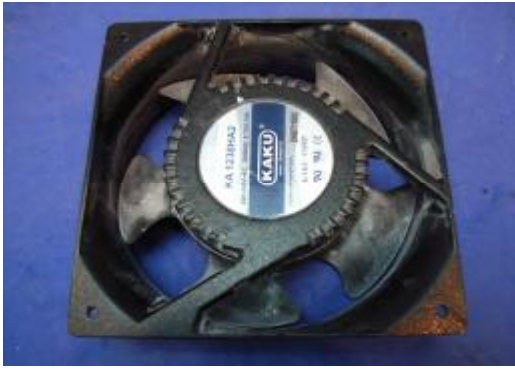
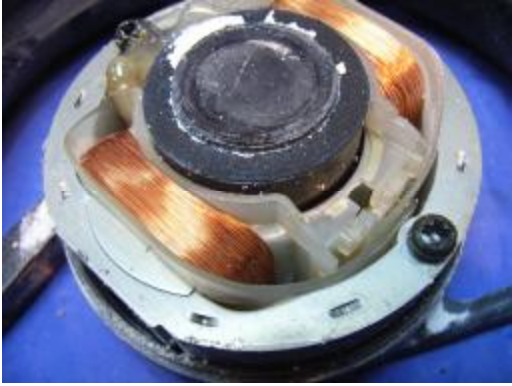
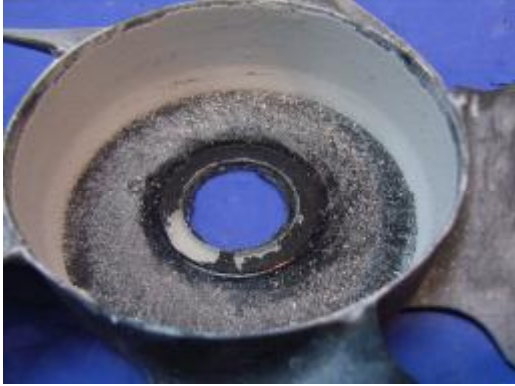
After IP5X	After IP5X

Ingress of dust was found in the sample, but the sample was still operating after the test.
